RECONNAISSANCE REPORT OF DAMAGE TO HISTORIC MONUMENTS IN CAIRO, EGYPT FOLLOWING THE OCTOBER 12, 1992 DAHSHUR EARTHQUAKE

**Reconnaissance Report of Damage
to Historic Monuments in Cairo, Egypt
Following the October 12, 1992 Dahshur Earthquake**

Technical Report NCEER-93-0016

August 19, 1993

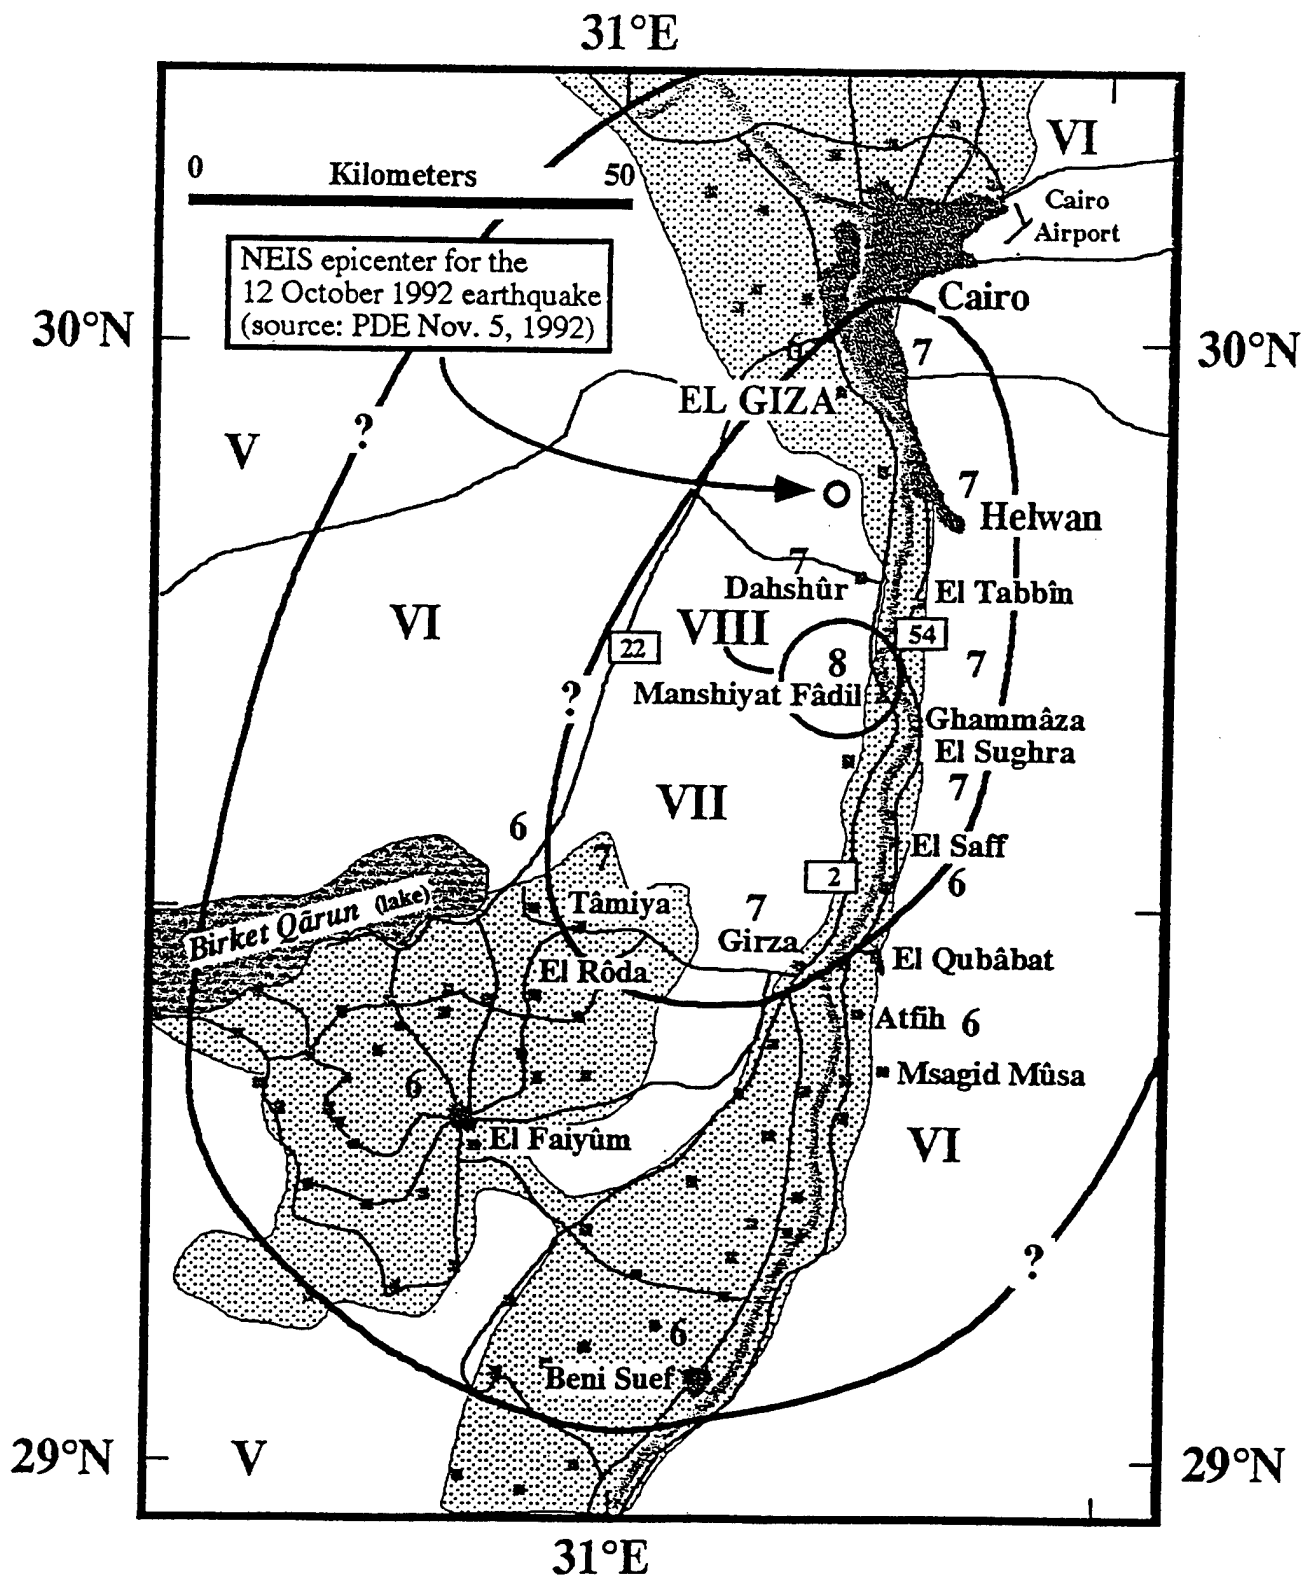
FIGURE 2-9 Iso-seismal map for October 12, 1992
Dahshur Earthquake (Thenhaus et al. 1993)

area defined by a seismic intensity of VIII (refer to figure 2-9). These manifestations included sand boils, earthquake-induced settlements of saturated soils, and lateral spreading and were documented shortly after the earthquake by Prof. Mohamed Amer at Cairo University (Elgamal, Amer, and Adalier 1993). An example of a remnant depression from a sand boil is shown in figure 2-10.

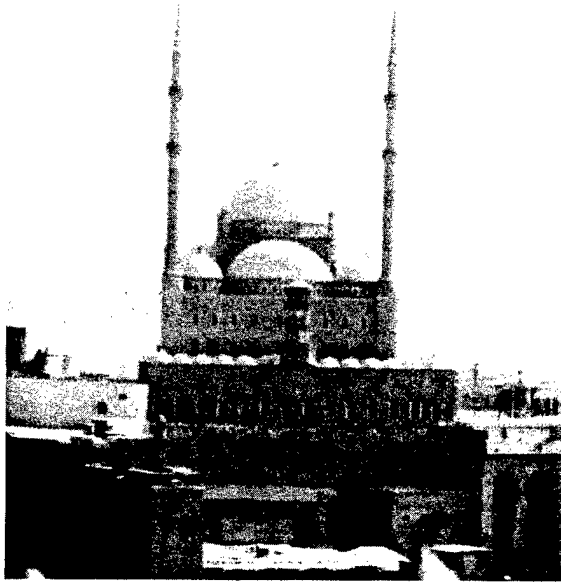
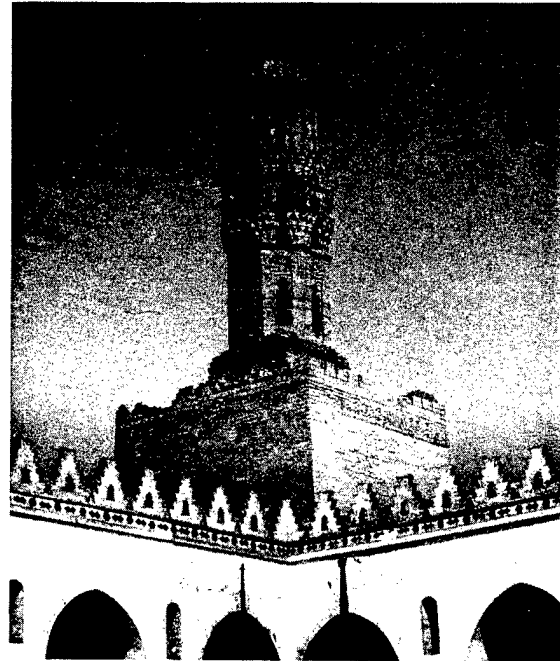
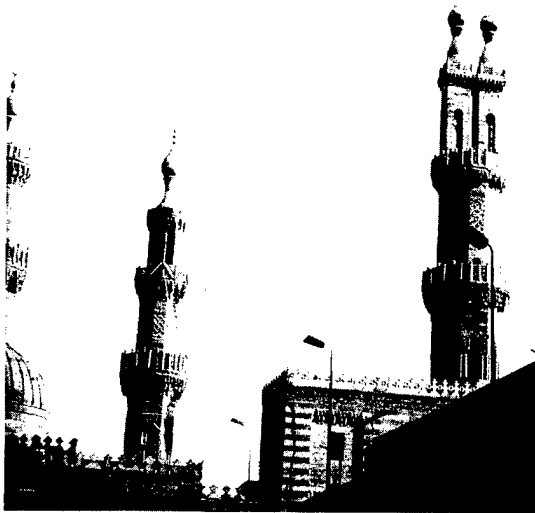
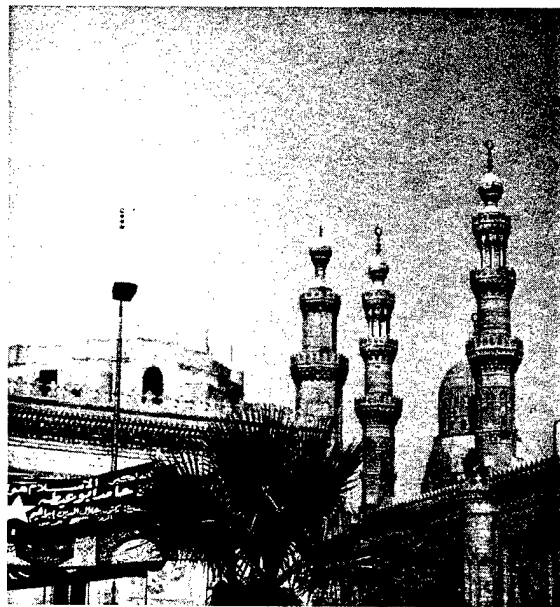
Portions of minarets have periodically fallen in Cairo due to earthquakes, deterioration, or poor design. For example, a minaret at the Mosque of Sultān Hasan fell shortly after construction and killed 200 children (Behrens-Abouseif 1985). Many of these minarets are likely to be in a state of marginal safety because of inadequate ties to the adjacent structure and poor foundation conditions. The general poor performance of minarets during this past earthquake attest to this conclusion.

The minarets in Cairo are not simple structures that can be adequately modeled with simple one-degree-of-freedom models. Unlike tall, slender minarets like those at the Mosque of Muhammad 'Ali al-Kabir shown in figures 4-9 and 5-1a (designed after minarets of Istanbul), most minarets in Cairo have varying cross-sections (and therefore moments of inertia) with some very weak portions (stalactites for mabkhara type used in earlier designs and at the base of bulb for later designs). Examples of variations are shown in figures 5-1b, c, and d and previously in figures 4-26 and 4-42. Therefore, computer modeling of minarets should be used to understand the behavior of different designs to suggest and model alternative retrofits and assist in the design of new minarets.

FIGURE 5-1 Different styles of minarets in Cairo
